# BASF CORPORATION

## FIRE TEST REPORT

NFPA 286 TESTING ON NEOPORE 5200 PANELS WHEN INSTALLED ON INTERIOR WALLS AND CEILING

103341001SAT-039

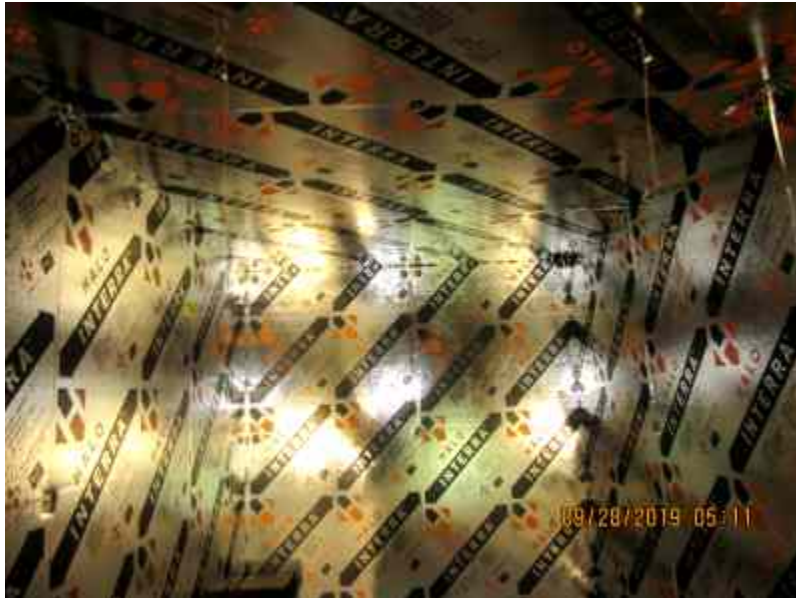
Photo No. 1  
Pretest photo

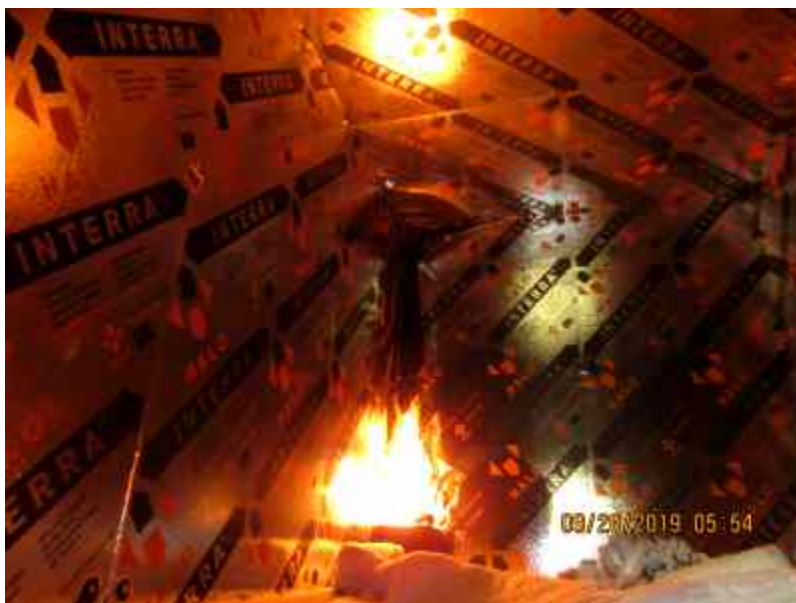
Photo No. 2  
40KW fire exposure

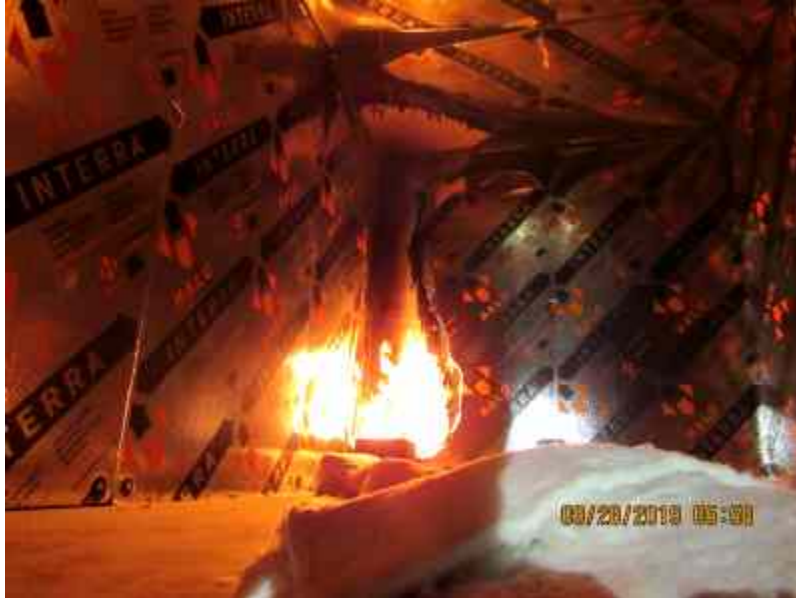
**Photo No.3**

**40kW**

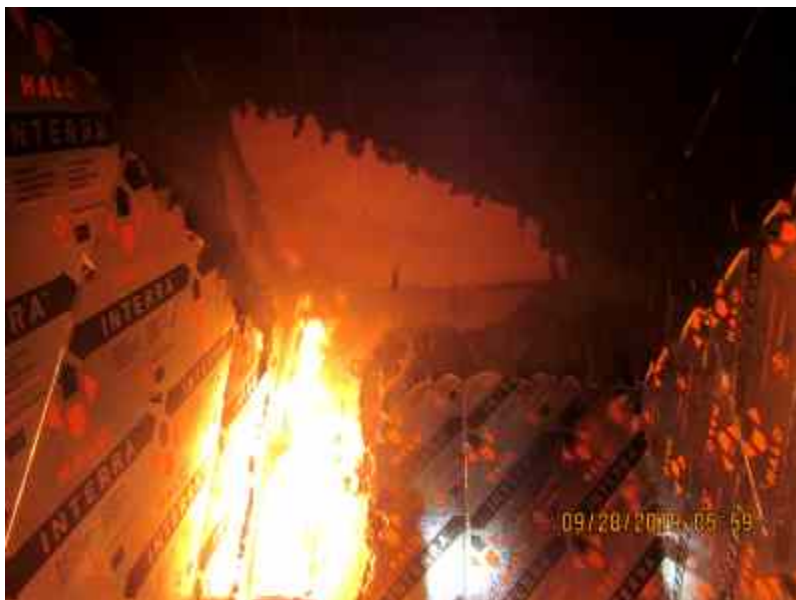
**Photo No. 4**

**160kW**

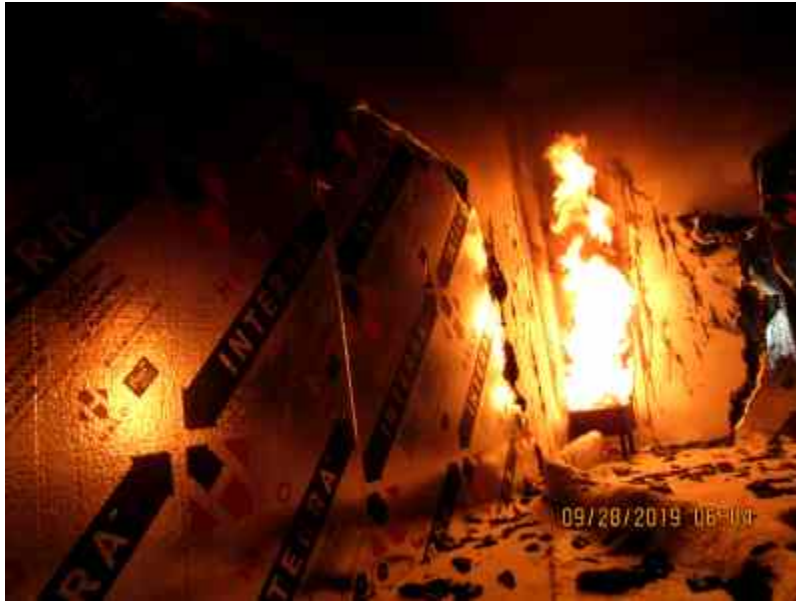
**Photo No. 5**  
**160kW**

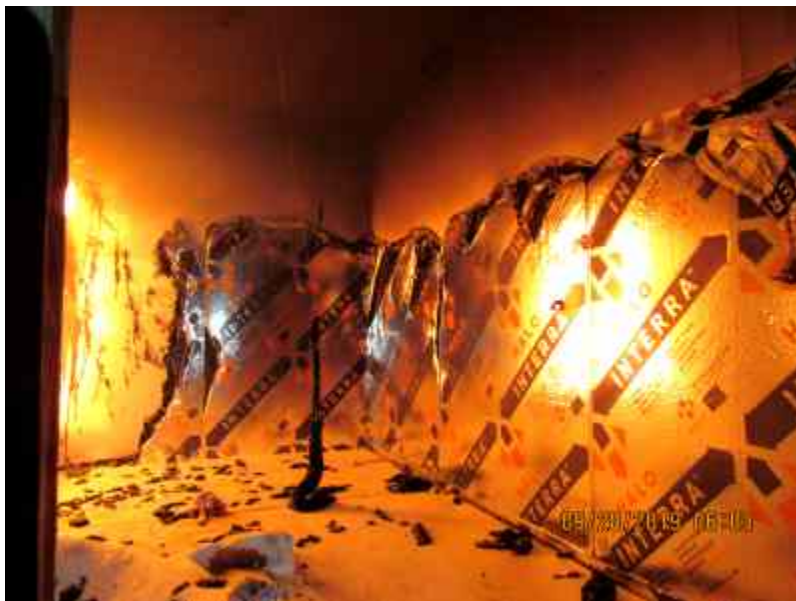
**Photo No. 6**  
**Foam consumption side wall opposite burner**

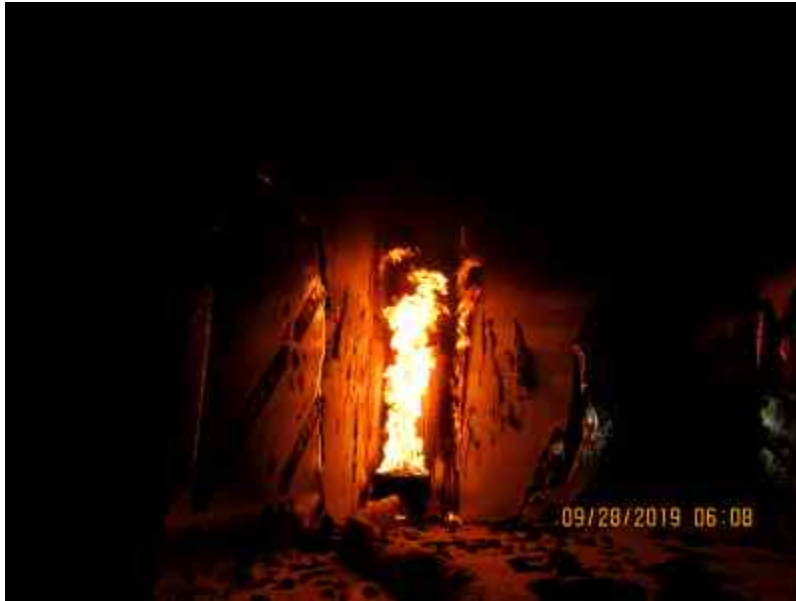
**Photo No. 7**  
**End of test**

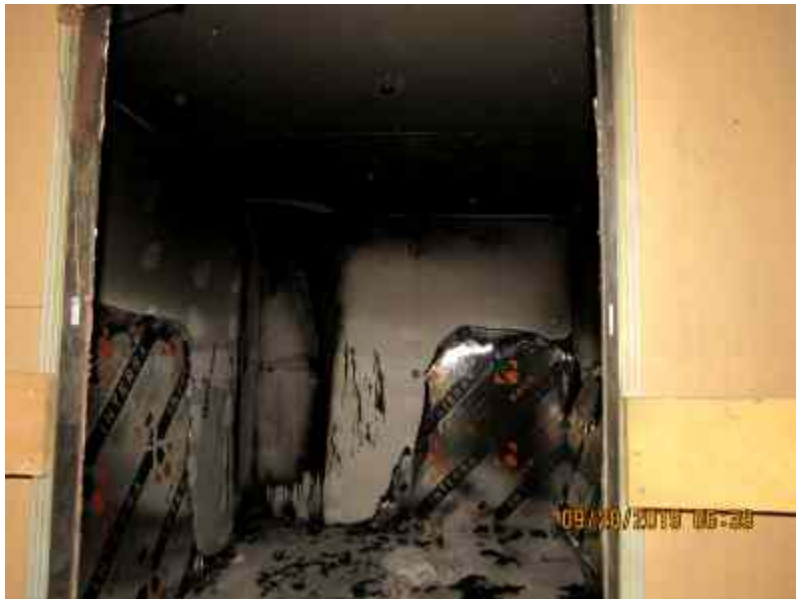
**Photo No. 8**  
**Post test**

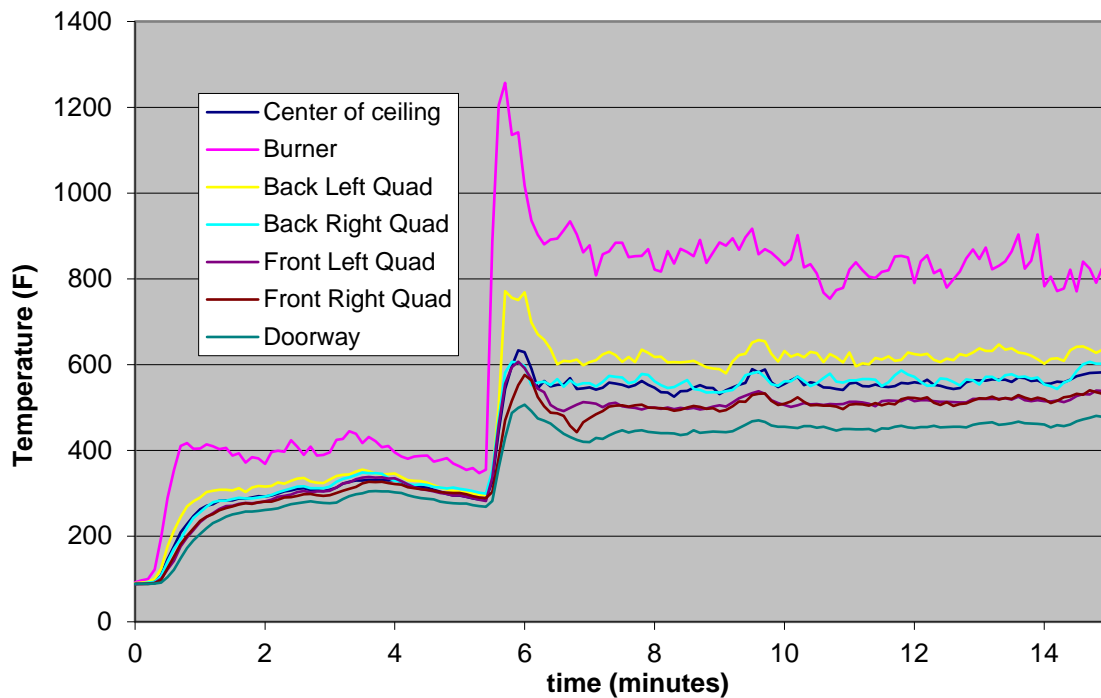
**Graph No. 1**

**Thermocouple Data**
